## UROŠEVAC - THE CHURCH OF HOLY KING UROŠ

### POSITION

Uroševac, the District of Kosovo, Diocese of Raška and Prizren

## CONDITION OF THE MONUMENT IN 2001

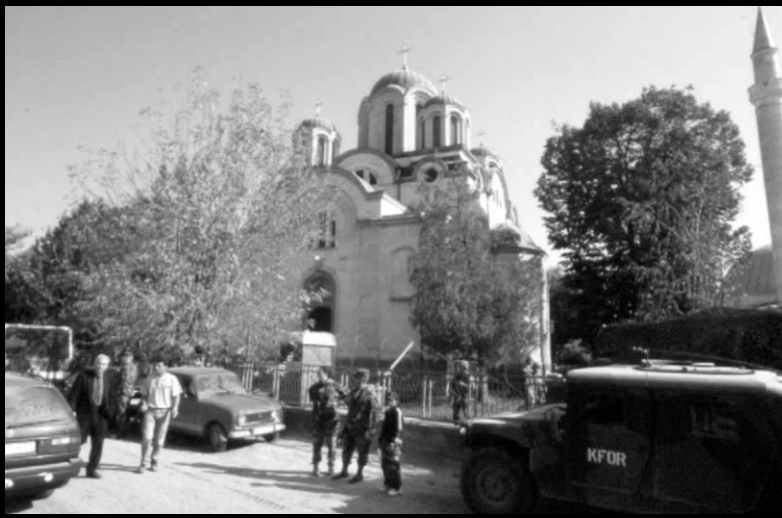
*The church, view from  
the southwest*

The church, situated in the city centre, is being protected by Greek KFOR units. In several places on the northwest part of the façade, mortar has fallen off, uncovering the structure of the wall: the church was built in brick bound with thick mortar joints. The two tones of paint were sprayed onto facades: the darker one in the socle, and the pale one on the remaining wall surfaces. Water pouring from the gutter damaged the mortar on the apse. The wall on the eastern side is wet because a part of the gutter is missing. Stains can be seen on the south wall and the part surrounding the entrance. They are made by pieces of garbage thrown into the churchyard.

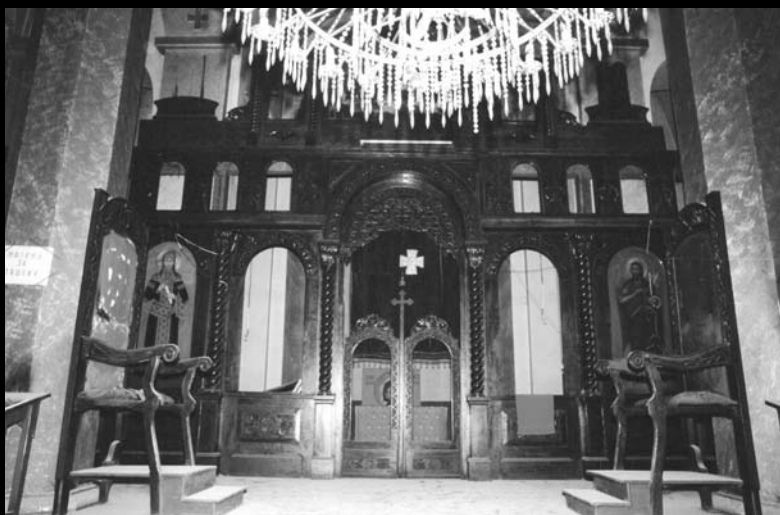
*The interior with the iconostasis*

The only icons left in the church are those representing Holy King Uroš and St John the Baptist. Minor damages of the thrones and iconostasis' plating have been recorded.
