ČABIĆI - THE CHURCH OF ST NICHOLAS

CONDITION OF THE MONUMENT IN 2001

**DOBRA VODA - THE
MONASTERY OF ST PETER
AND PAUL**

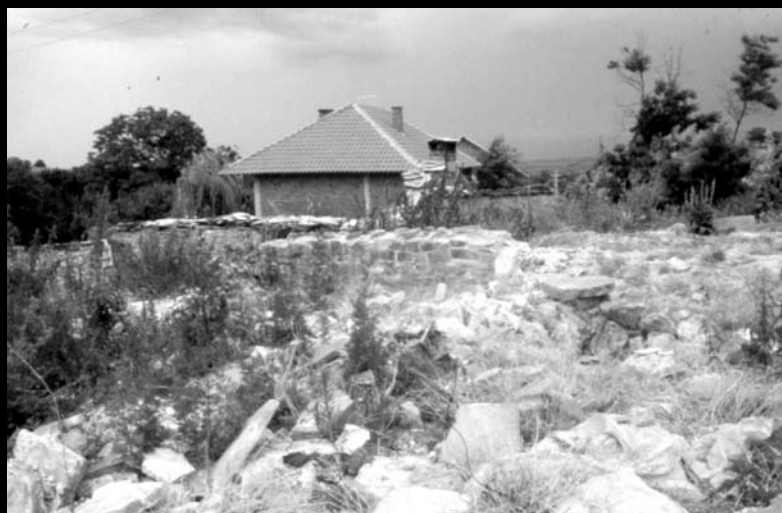
*Remains of the church
in 2001*

The Church of St Nicholas in Čabici was levelled with the ground. The ruins are run into weed and covered with litter. Building material, which obviously was not that of the church, was added to the rubbish heap.

Judging by the appearance of the church site, where dried weed was also found, it could be supposed that the church has been in ruins for at least two years. No traces of fresco decoration, dated to the end of the 15th or the beginning of the 16th century, were found. There is a possibility that some fragments are still among the rubble that has been left after the church had been demolished, and that they have been exposed to all kinds of weathering factors for months.

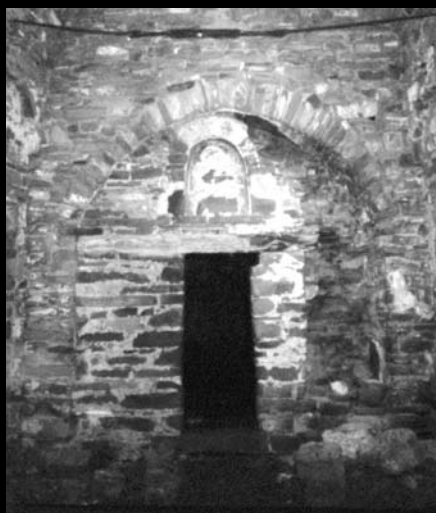
The west wall of the nave with the remains of fresco decoration

The border of the recent damage beneath the head of St Joachim shows that fresco mortar detached from the wall. It is feared that preserved part of the fresco may fall off. A copy of the fresco was made during restoration works and is kept in the Fresco Gallery in Belgrade.

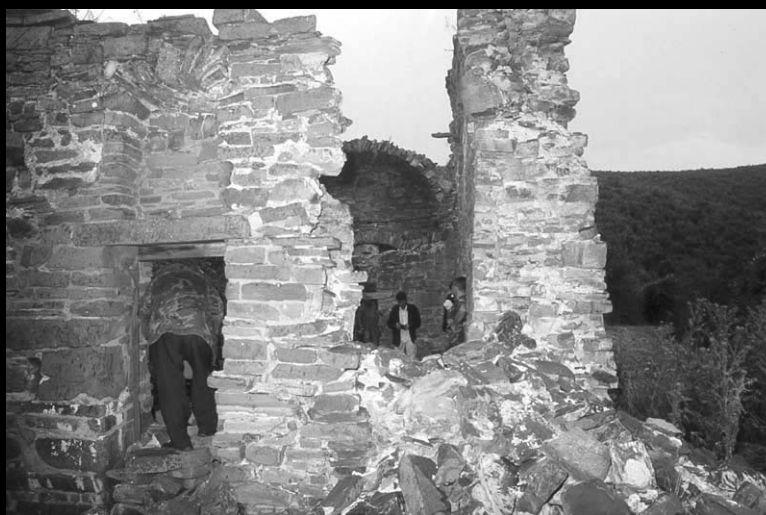
According to an Albanian boy who was leading KFOR soldiers, the southwestern part of the exonarthex was damaged during a KLA shooting drill from a nearby hill.

Southwestern corner of the exonarthex after the grenading

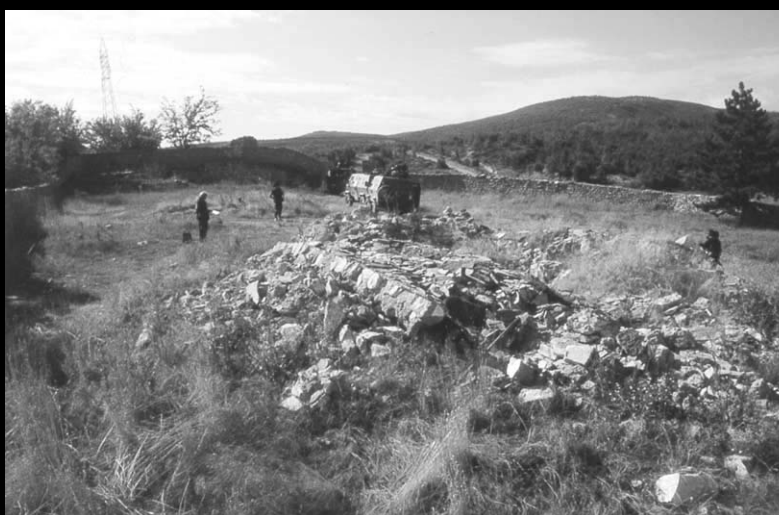
Remains of the church and the enclosing wall, view from the northeast

Parts of the church walls and the apse, reaching 1.20 m in height are still in their original position. The belfry

Although a part of the building material has been taken from the site, the remains of stone slate roofing, blocks of wall made of stone, limestone and bricks bound with lime mortar, and deformed remains of reinforced concrete cerclages indicate that the explosion must have been strong. Precise condition assessment and establishing of deterioration rate would be possible only after the rubble is cleared away.

Owing to the fact that the floor of the church was lower than the level of the ground, the inner walls have been preserved up to about 1m in height but are currently covered with rubble. It is possible that a part of the fresco decoration has been preserved in this zone.

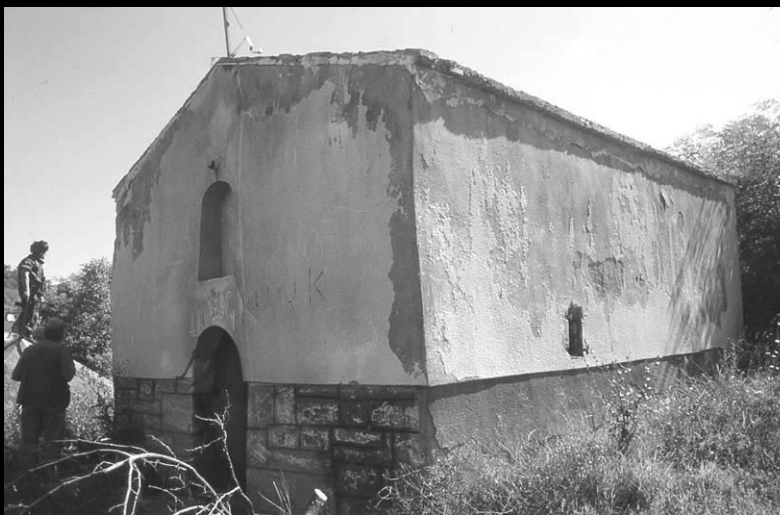
*The church after being
burnt down, view from
the southwest*

The church was preserved as an architectural whole. Its interior was destroyed in the fire – all the wooden bracing elements and the wall-plates against which they were leaning were completely burnt down. Metal crosses that used to be mounted on the church and the belfry were vandalized and torn down.

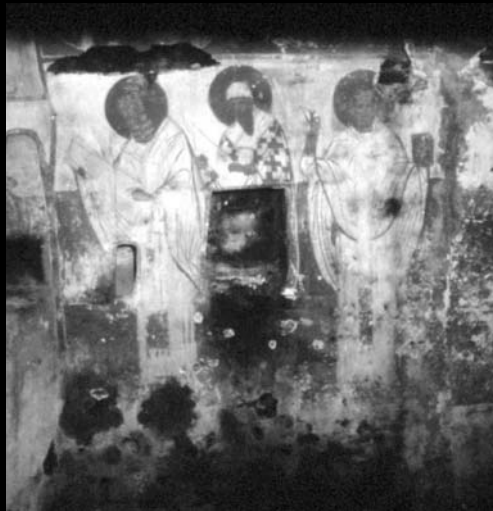
The south wall of the nave,
frescoes after the fire

High temperatures, caused by the fire, completely destroyed the paint layer, the upper zones of which are now covered with a layer of soot, while the general tone of the other parts was shifted toward reddish and brownish hues of earth pigments, rich in iron-trioxide. When exposed to high temperatures, iron-trioxide changes into iron-dioxide and acquires the colour of rust. Husks contained by fresco mortar mostly burnt, leaving holes in the mortar. Fresco mortar is now crumbly. There are hollows in the walls left after the burnt bond-timbers. In these places, the support of the fresco mortar was destroyed, which resulted in falling off of the fresco layer. The iconostasis was completely destroyed in the fire.

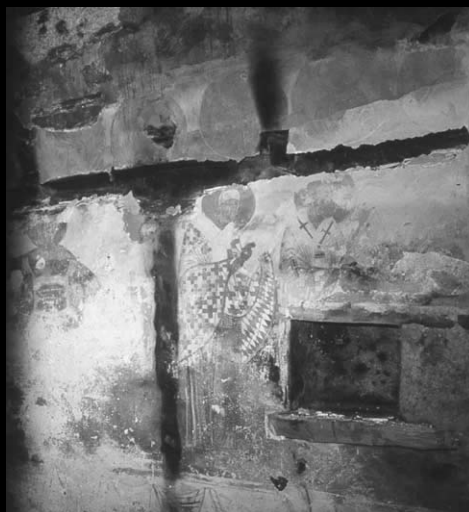
The south wall of the nave, frescoes after the fire and burned wooden beams in the wall

furnishings, can be seen in the interior of the church. Damages of fresco decoration, caused by high temperature indicate that the furnishings of the church were not the only burning agent, since their combustion could not produce such a high temperature. A large heap of dry twigs was found in front of the church entrance, which had obviously been used to fuel the arson.
