**KIJEVO - THE CHURCH OF  
ST NICHOLAS**

**KIJEVO - CRKVA SVETOG  
NIKOLE**

## **MLEČANE - THE CHURCH OF ST NICHOLAS**

## **MLEČANE - CRKVA SVETOG NIKOLE**

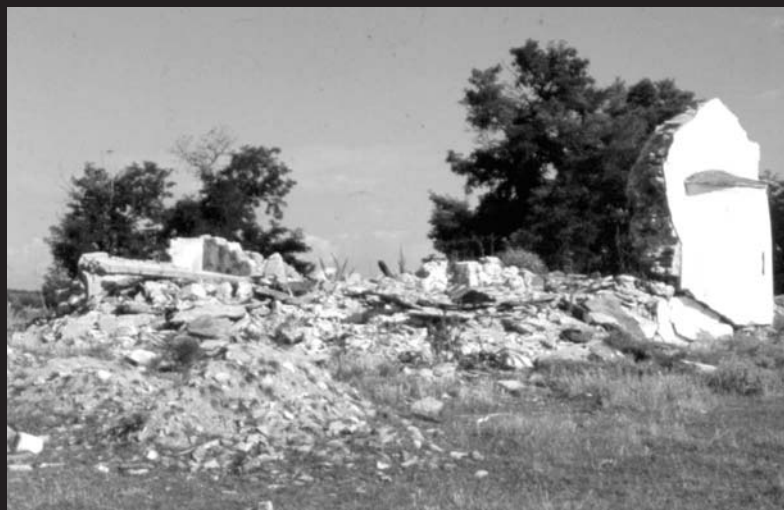
*Ruins of the church and the narthex, view from the south*

Рушевине цркве и припрате, поглед са југа

The church was mined and levelled with the ground by the Albanian extremists, after the arrival of KFOR. The only preserved part is the eastern wall of the nave with the altar niche. It remained in vertical position, though a horizontal crack detached it from the foundations, shifting it for about 30 cm eastward.

The narthex was destroyed. While visiting the site, on July 18, 2001, not a single fresco fragment was found. It is possible that some fragments of the smashed fresco decoration can be found in the rubble.

Црква је минирањем срушена до темеља од стране албанских екстремиста, након уласка КФОР-а. Сачуван је једино источни зид наоса са олтарском нишом. Остао је усправан, иако је у корену хоризонталном пукотином одвојен од темеља и око 30 цм измакнут ка истоку.

Припрата је срушена до темеља. Приликом боравка на терену 18.7. 2001. године није пронађен ниједан фрагмент живописа. Постоји вероватноћа да у шуту рушевине има делова изломљеног живописа.

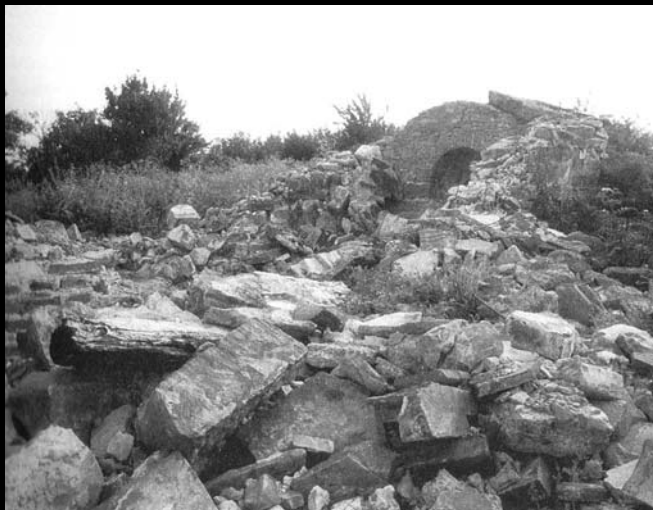
Escorted by the Italian KFOR unit, Mnemosyne Centre team of experts visited the site on July 18, 2001. It has been established that the church was demolished, according to the soldiers, most probably by grenading. A grenade crashed into the western part of the church, but the explosion failed to destroy the eastern wall with the altar apse, and lower sections of southern and northern walls of the nave. Severely damaged fragments of fresco decoration that underwent conservation treatment can be seen on the northern and southern walls. The lower parts of the walls are, however, covered with rubble.

У пратњи италијанских јединица КФОР-а, стручна екипа Мнемосине центра изашла је на терен 18.7. 2001. и установила да је црква срушена, по речима војника из пратње, вероватно гранатирањем. Граната је погодила западни део цркве, пошто детонација није срушила источни зид са олтарском апсидом и источне доње делове јужног и северног зида наоса. На овим зидовима (деловима северног и јужног) налазе се веома оштећени фрагменти конзервираног живописа, чији су доњи делови затрпани каменом грађом порушених зидова.

*Ruins of the church, view  
from the southwest*

Рушевине цркве, поглед  
са југозапада

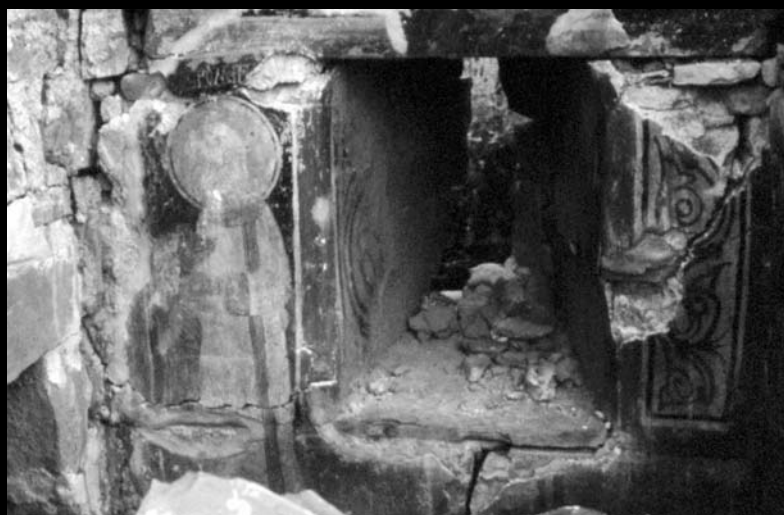
The other parts of fresco decoration, on the walls that were shattered by a detonation show numerous cracks.

Преостали делови живописа испуцали су на остацима зида растрешених детонацијом. Фреско-малтер је у великој мери око пукотина

*Remains of the fresco  
decoration, nave, the  
south wall*

Остаци фресака на  
јужном зиду наоса

Fresco mortar around the cracks has mostly fallen off. Although there are areas in which fresco mortar is still fairly well attached to the support, the major part of it is detached and likely to fall off – along the borders of the recent damages in particular. Lime mortar fillings applied in 1968 on the borders of damages are still well attached to the fresco mortar, which enables us to make a clear distinction between the old damages and the recent ones.

потпуно отпао, местимично је у доста доброј вези са зиданим носачем, док је на већини површина одвојен од њега, нарочито по рубовима новонасталих оштећења и прети му опасност од даљег отпадања. Опшиви из 1968. године, рађени кречним малтером по рубовима тада постојећих оштећења, и данас су у релативно доброј вези са фреско-малтером, што јасно дефинише рубове новонасталих оштећења.
