**SRBICA - THE MONASTERY
OF DEVIČ**

CONDITION OF THE MONUMENT IN 2001

**BANJA RUDNIČKA
THE CHURCH OF ST NICHOLAS**

LEOČINA
THE CHURCH OF ST JOHN

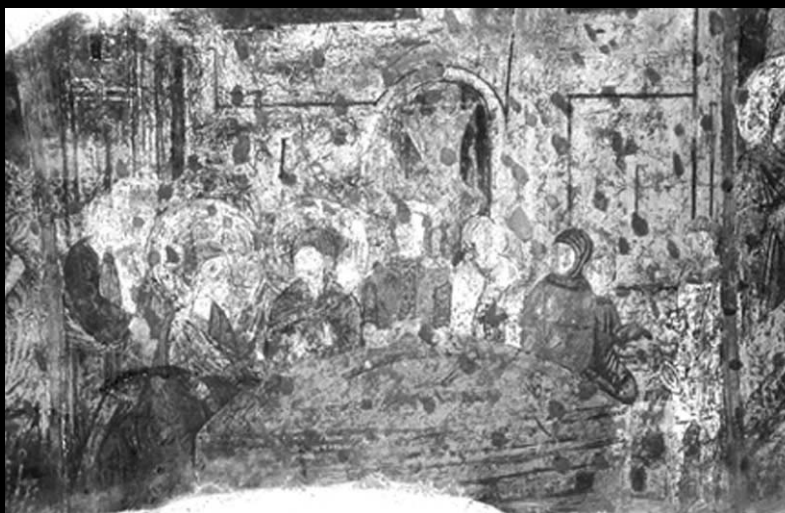
A fresco in the sanctuary

The condition of the frescoes in the sanctuary is quite stable. Occasional air cushions and detaches can be noticed. All the compositions are tarnished with soot and dust.

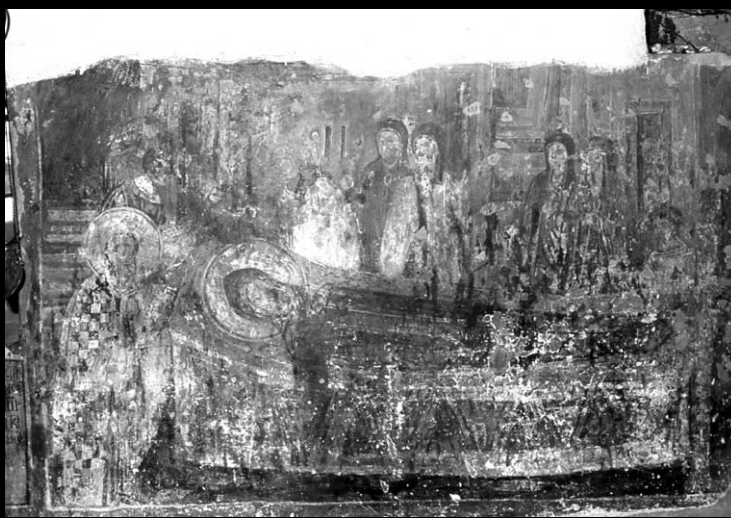
St Joanikije lying on the bier, the fresco in the chapel of St Joanikije

The most severely damaged are the frescoes in the chapel of Holy Joanikije, which were uncovered by strapping of oil murals. The results of earlier conservation interventions can be seen. The frescoes are painted on classical fresco ground made of fresco mortar reinforced with chaff. Fresco layer is picked, covered with the network of cracks, detached from the wall, worn out and tarnished with dust and soot.

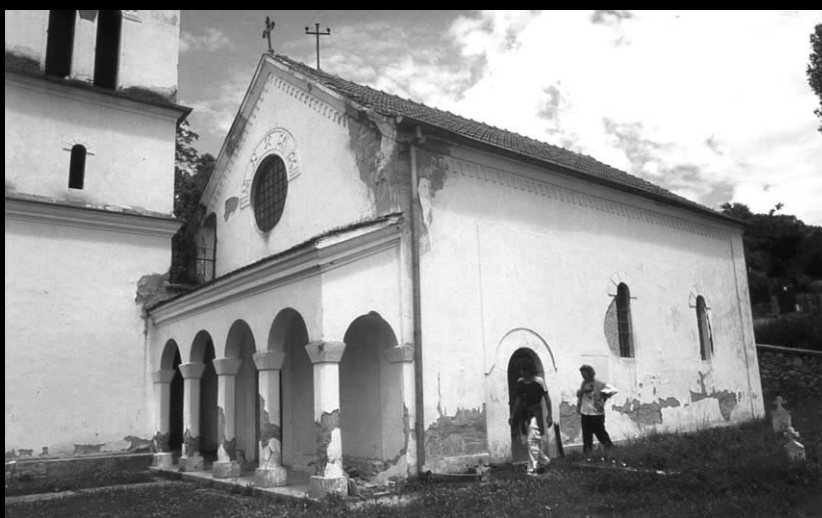
The church and the belfry, view from the southwest

The mortar coating of the façades has almost completely fallen off: from the zone under the eaves, as well as from the columns, gable and lower zones of the walls. The roof has been covered with new pantiles. Due to inadequate size of the gutters, rainwater, however, pours down the walls, deteriorating them. Since the paving of the ground around the church has not been finished, the consequences of the penetration of humidity into the foundations can be noticed.

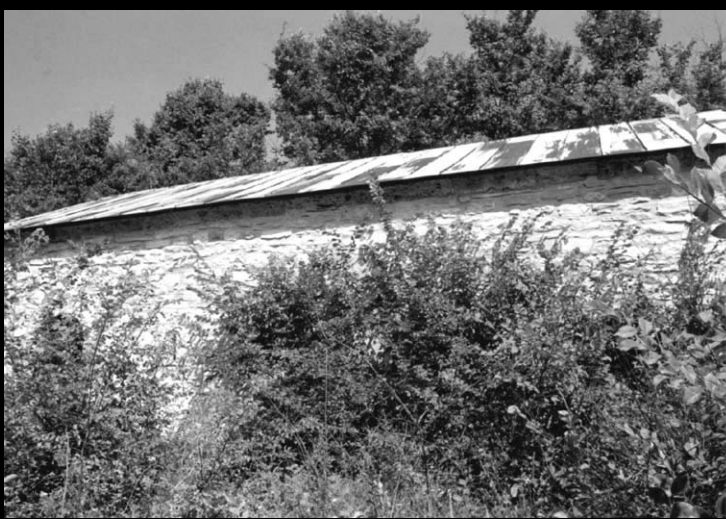
The south façade of the church

There is no road leading to the monastery. It has neither running water, nor electricity supply. The church has been demolished and ravaged. Its roof has been ruined. The church has run into weed, while the terrain on which it was built has been overgrown with underwood. An old tombstone was brought into the narthex. Since somebody used to make fire in the narthex, its walls are covered with soot. The church is situated in the region populated by ethnic Albanians, and has neither protection, nor appointed guard.
