C/I-00.15

**ЂУРАКОВАЦ - THE CHURCH
OF ST NICHOLAS**

CONDITION OF THE MONUMENT IN 2001

**KOŠ - TOMIĆ'S
RESIDENTIAL TOWER**

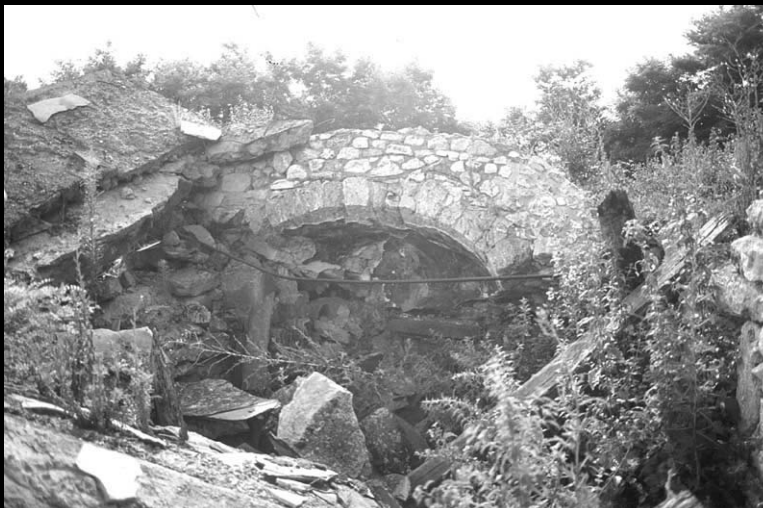
Ruins of the eastern part of the church with the remains of fresco decoration

Рушевине источної дела наоса са остацима фресака

The ruins are run into weed. Underneath the rubble and the wooden roof construction of the church and the narthex, only the apse section with 1.5 m high conch, showing the traces of fresco decoration, can be seen. The Royal Doors and two icons of the Sovereign Row, as well as a carved door-post, have been taken out from the rubble and taken to the monastery of the Patriarchate of Peć.

Рушевине цркве су обрасле у висок коров. Испод зарушеног камена, шута и дрвене конструкције крова цркве и припрате, назире се само део грађевине према апсиди, са зидом калоте висине око 1,5 м, на коме су видљиви трагови фресака. Царске двери и две престоне иконе извађене су из рушевина и пренете у Пећку патријаршију са делом дуборезног довратника.

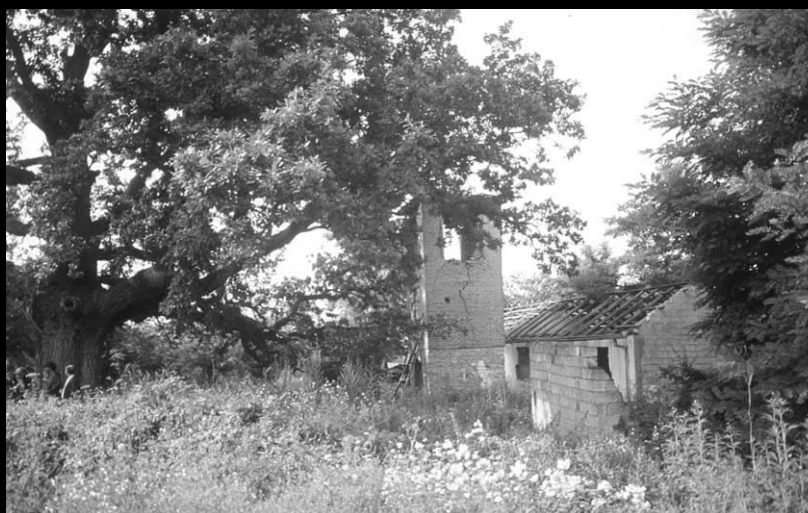
Ruins of the belfry and the parish house, and the mined oaktree, view from the east

Рушевине звоника и парохијској дома са минираним храсћом, поглед са истока

The church was mined and destroyed after the arrival of the Italian KFOR units in July 1999. A belfry, of considerably shattered structure, with visible vertical cracks, and the remains of the roofless parish house, without doors and windows can be seen by the church. An old oak tree was also mined but its trunk has been preserved.

Црква је минирана и разорена након доласка јединица италијанског КФОР-а у јулу 1999. Поред разрушене цркве стоје звоник, растресен, са видљивим вертикалним пукотинама, и остаци парохијског дома без крова, прозора и врата. Миниран је и стари хрст, али је главно стабло сачувано.

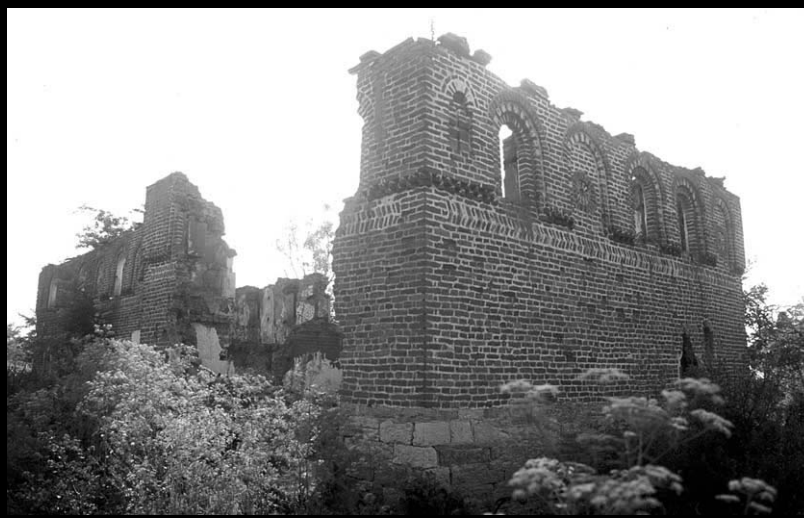
*Ruins of the tower,
view from the road*

*Рушевине куле,
погледа са пута*

The village has been deserted. The tower was pulled down at the end of 1999. Floor and roof construction are completely destroyed. Unprotected.

Место је напуштено, а кула срушена крајем 1999. У потпуности су уништене спратна и кровна конструкција. Необезбеђено.
